Periodic Inspection of Nawiliwili Harbor Breakwater, Kauai, Hawaii

Report 1

Base Conditions

by Robert R. Bottin

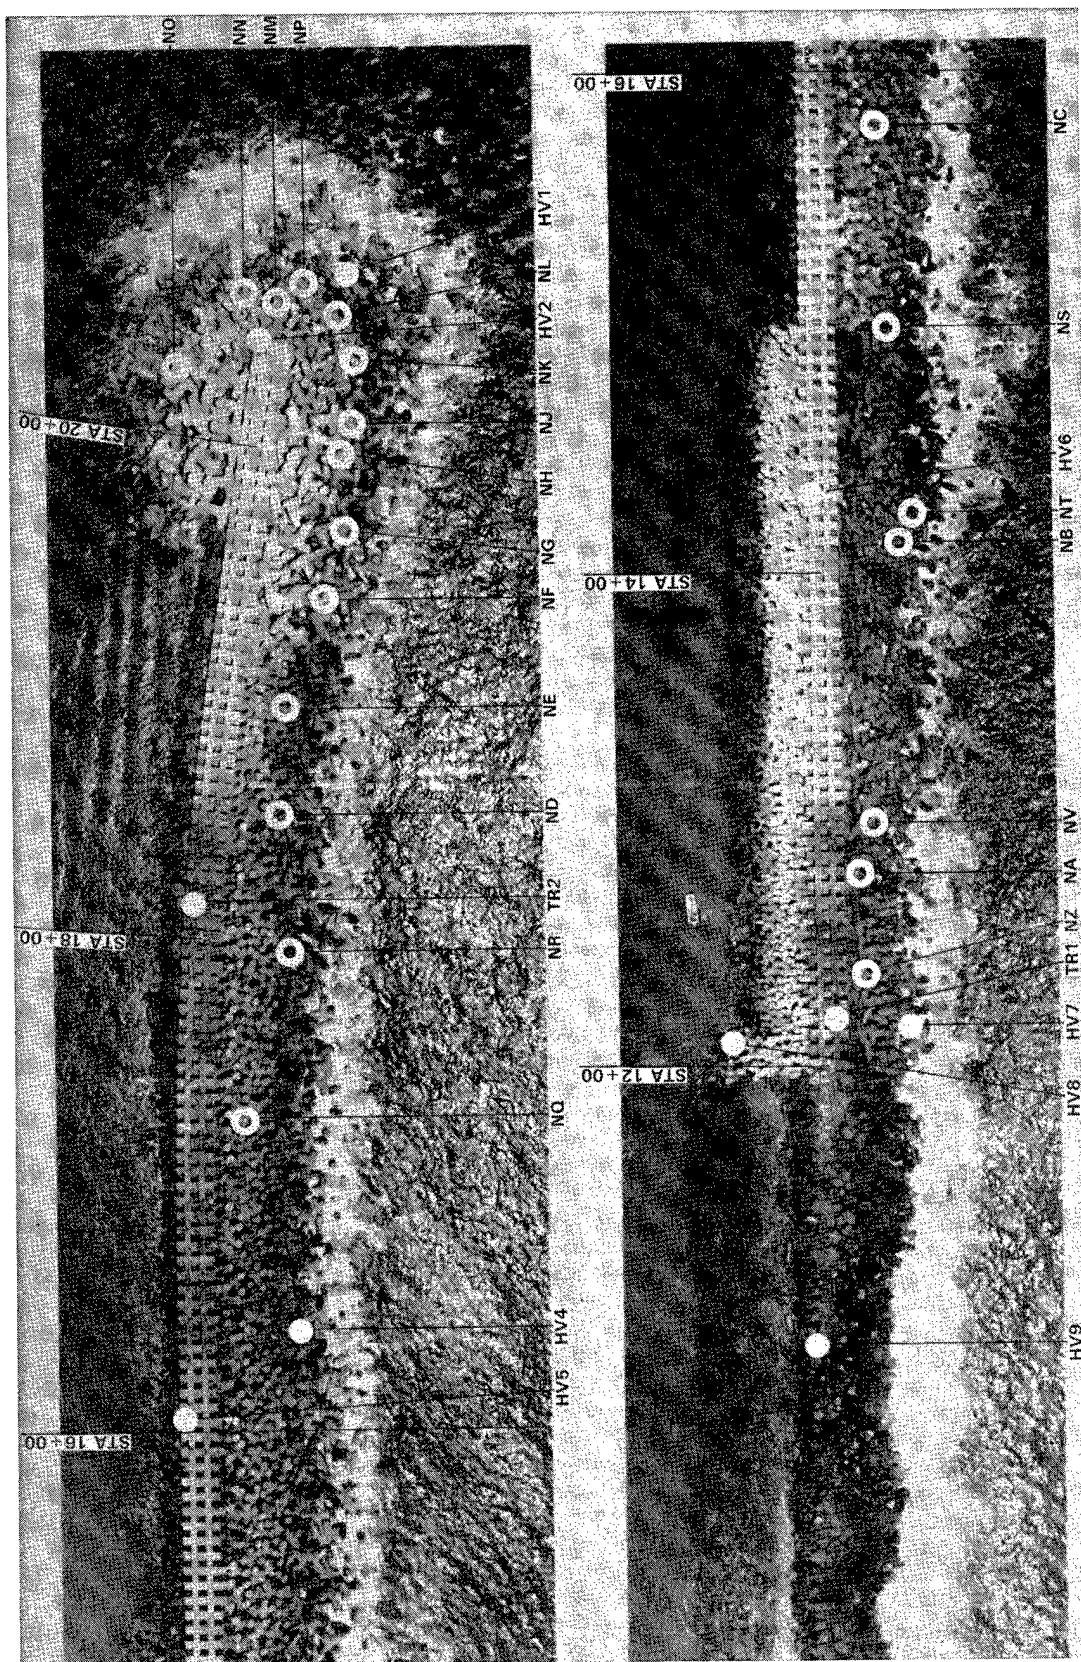
Figure 8. Locations of control points and targeted armor units on Nawiliwili breakwater

Control points were established on the breakwater to serve as control (both horizontal and vertical reference) for the ground-based survey work as well as the photogrammetric work. Ground surveys were initiated from known monuments on shore. Positions and elevations of the control points established on the structure are shown below and in Figure 8.

In addition, targets were established on selected concrete armor units to serve as a control to check the accuracy of the photogrammetric work. A total of 21 armor units were selected for targeting, 11 along the sea side of the breakwater trunk and 10 around the breakwater head. Along the trunk,

9 of the targeted units were 9,980-kg (11-ton) dolos, and two were 16,150-kg (17.8-ton) tribars. Around the head, 5 units were 20,865-kg (23-ton) dolos, and 5 were 16,150-kg (17.8-ton) tribars. Selected units were distributed along the outer 260-m (850-ft) length of the breakwater and from the crest to the waterline. Dolosse and tribars were chosen roughly in proportion to the relative frequency of each unit along a particular length of breakwater. Units were chosen for targeting that had flat surfaces close to horizontal to maximize their visibility in aerial photography and allow for accurate representation of armor unit movement. Figure 8 shows the locations of targeted armor units on the Nawiliwili Harbor breakwater using an identifier of NA, NB, etc.

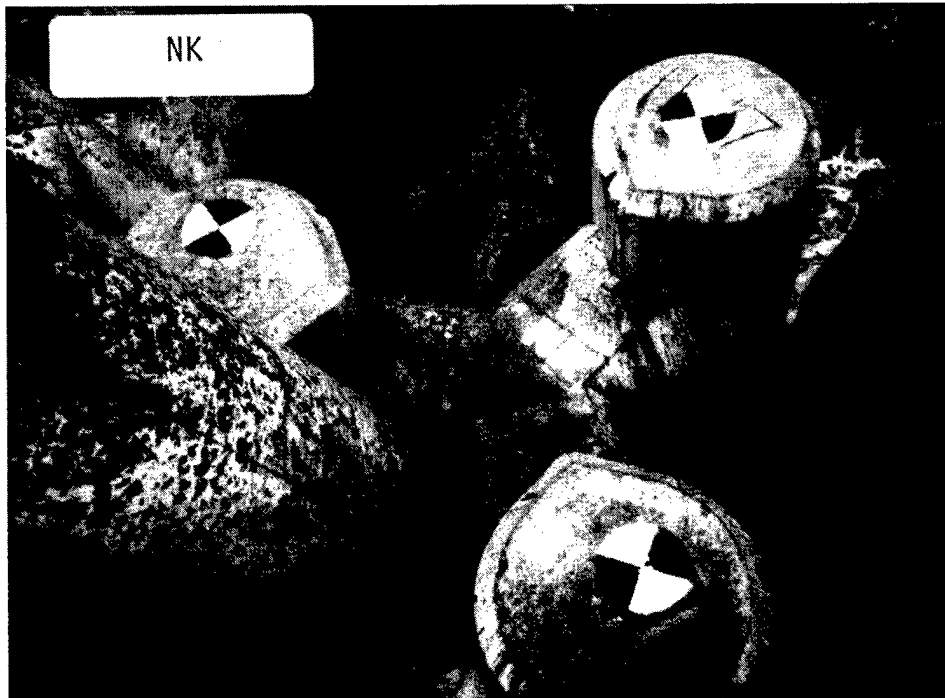
Figure 9. Example of a targeted 17.8-ton tribar

Each armor unit selected for targeting was painted with three 30.5-cm- (12-in.-) diam targets. The targets were divided into four quadrants which were painted alternately white and black. This style of contrasting target provides a precise center point for which measurements can be made by both land surveys and photogrammetric work. A high-quality epoxy-based marine paint was used to minimize the need for repainting, and a 2.54-cm (1-in.) cross was chiseled at the center of each target for identification in subsequent surveys. Each targeted unit was labeled conspicuously with two 15.2-cm- (6-in.-) high white letters, the first being "N" for Nawiliwili and the second being an identifying letter for the particular unit. Each target on its respective armor unit was identified with a single 15.2-cm (6-in.) white numeral labeled "1" through "3." Examples of targeted armor units are shown in Figures 9 and 10.

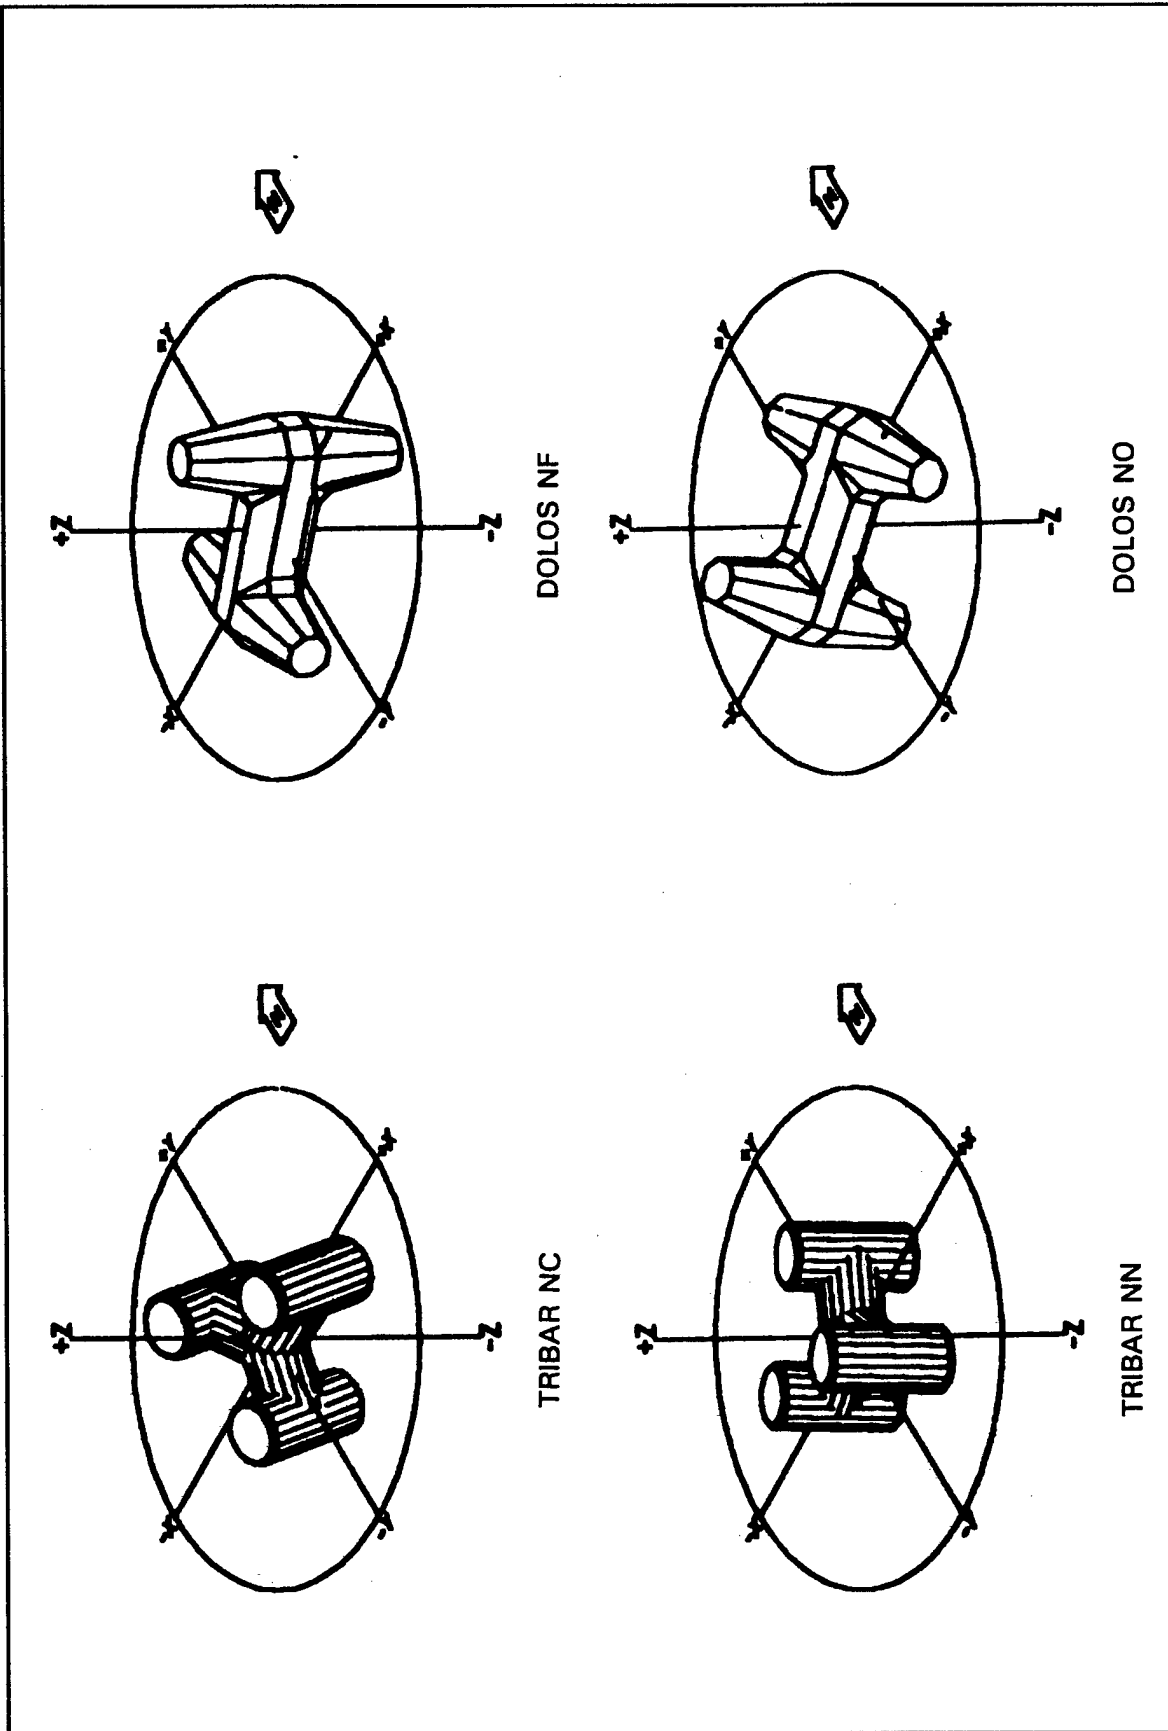
Figure 13. Representative targeted armor unit positions relative to x, y, and z axes

With the x, y, and z (easting, northing, and el) coordinates defined for each target on the various armor units, the centroid of each targeted armor unit was computed. In addition, the position of each armor unit relative to the x, y, and z axes was determined. Figure 13 shows the orientation of representative armor units to the three axes. The centroid of each targeted armor unit and each unit's orientation (rotation angle relative to x, y, and

z) are presented in Table 2 for the aerial survey results. These are base level conditions from which comparisons can be made in future surveys.
